Safety Inspection Report

Annual Inspection

The Cricket Ground

11 July 2025

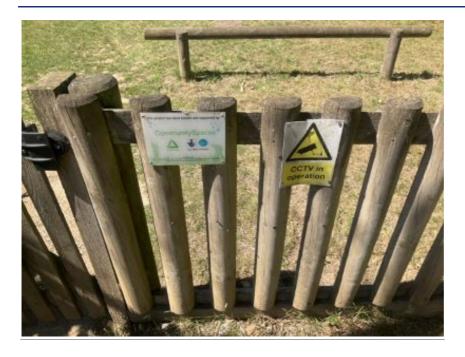
Signage

Dog ban & ownership signs recommended.

See https://www.rospa.com/en/Play-Safety/Advice/Signs

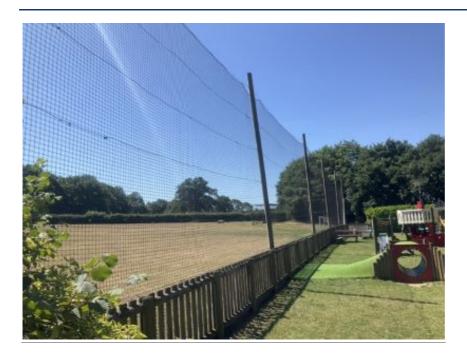
Fencing - Ball Stop

This equipment relies on one post for its stability. Special attention should be paid to maintenance (e.g. by monitoring degradation) and if necessary decommissioning the item before the end of its operating life. This is a requirement of the British Standard.

Posts leaning.

Consult with the manufacturer's guidance to determine suitable maintenance.

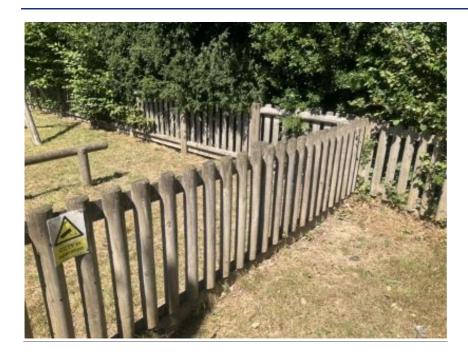
Fencing - Timber Paling

Moderate repairs are needed.

Strimmer damage is present. Prevent further damage. Monitor all timber posts for decay throughout the year due to softening. Replace affected parts if found/necessary.

Replace., Repair.

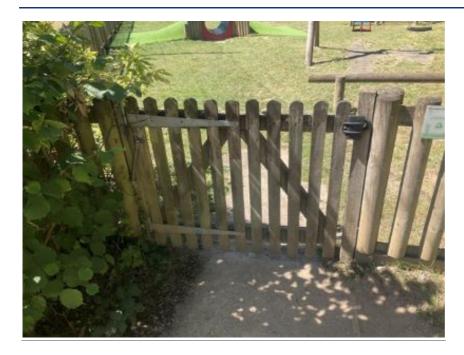
Gates

There is a crushing or shearing point on the side of the gate. Where the gaps reduce to less than 12 mm these have been known to cause serious, permanent injury to children, especially on the hinge side where the leverage forces are significant.

Gate closest to basket swing. Adjust. Replace decayed timbers on gate.

Adjust gate / posts / fit new rubber buffer to ensure a spacing of at least 12 mm throughout the range of the gate to remove the entrapment. The 12 mm gap also should apply on the hinge side of the gate., Read the notes for further action.

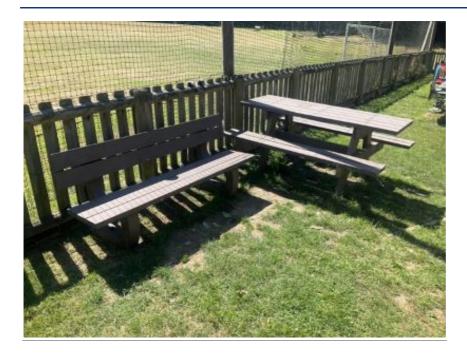
Seating - Various

Portable equipment must remain outside the minimum space of the permanently installed items. Free movement of children within the play area may be affected. Without effective control the risks will increase. The risks associated with portable equipment will vary depending upon where the unit is placed.

Vandalised (arson).

Picnic table top.

Monitor and control the placement of portable items.

Consider securing in a suitable location.

Repair.

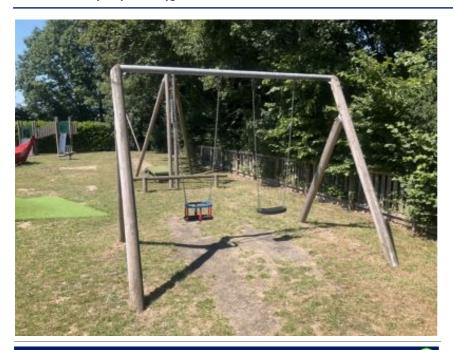
Swing - Mixed - 1 Bay 1 Junior 1 Toddler Seat

Strimmer damage is present on posts, allowing water to enter and timbers to soften. It can also remove the protective envelope around the timber. Prevent further damage and check timbers for decay throughout the year.

Bird fouling present.

Prevent further damage.

Consider fitting an anti-bird strip or upward-facing cable ties to the top bar to prevent birds from landing., It is recommended that playground equipment be regularly checked for bird fouling - if found, the affected items should be cleaned with a disinfectant solution.

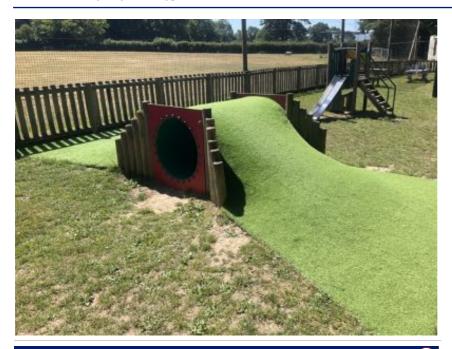
1. The equipment is easily accessible, has a free height of fall exceeding 600 mm, but does not have barriers to the standing surface.

Timber is not in good condition.

Monitor all timber items for decay throughout the year due to softening at ground level. Replace affected parts if found. Splintered and damaged timbers.

Surface needs repair.

Artificial grass lifting and grass eroded.

Tunnel bulging in areas.

Replace affected parts., Repair.

Build up ground levels to remove trip hazard., Consider adding grass matting to prevent wear.

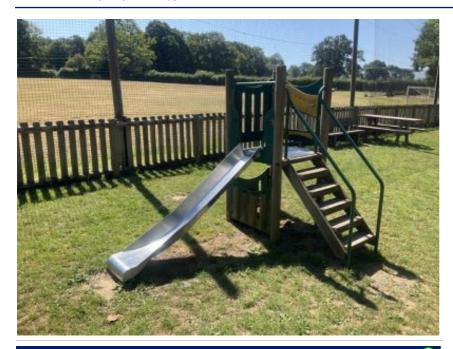
Multiplay - Toddler

Strimmer damage is present on posts, allowing water to enter and timbers to soften. It can also remove the protective envelope around the timber. Prevent further damage and check timbers for decay throughout the year.

Monitor all timber items for decay throughout the year due to softening. Replace affected parts if found/necessary.

Sun facing slide. Slide was very hot at the time of the inspection. Consider relevant signage.

Bolt(s) loose.

Barrier bolts.

Prevent further damage.

Tighten.

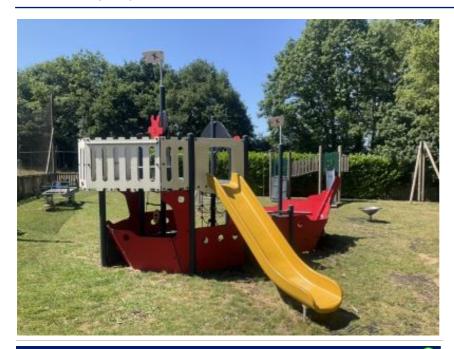
Play Boat

Fixtures loose or missing.

Dial panel creating pinch points.

Top sail is very loose and could be removed. Cap/s are missing allowing water ingress into the frame and fixtures. Replace.

Moving parts require greasing.

Hammock swing.

Tighten.

Apply lubricant according to the manufacturer's instrutions.

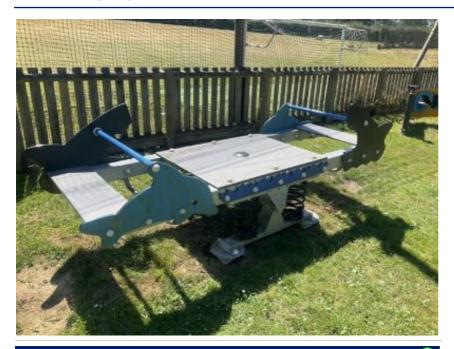
Rocker - Seesaw - Multi-Seat

Ground erosion present.

Holes forming.

The equipment is dirty or algae covered.

Repair the worn areas.

Clean off.

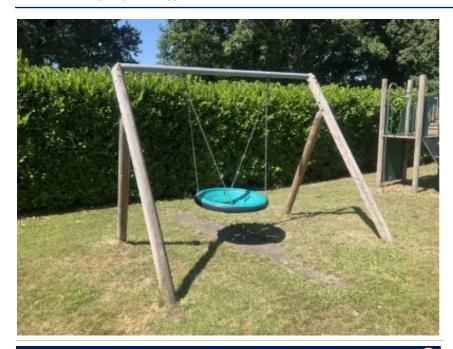
Swing - Basket

A secondary support device is required to prevent collapse in the event of supporting component failure.

Timber is decayed.

Highlighted older support is decaying at ground level. However, structurally stable at the time of the inspection.

Item has some parts missing.

Seat edge joints. Impacts on hard leading edge are possible. Underside seat and framework caps are missing. Replace.

There are natural splits / shakes in the timbers.

Uneven chain links on one side allowing the seat to lean forwards. Adjust.

Hard or sharp projections.

Butterfly shackles have been used.

Some chain wear.

Refer to manufacturer for comment.

Check on a routine basis., Replace affected parts.

Replace the missing parts.

DO NOT fill shakes. Monitor and sand back any splintered edges as required., DO NOT fill shakes. Shakes vary. Monitor and consult manufacturer if dimensions exceed 8 mm at sections used to grip / grasp.

Remove hard, pointed and sharp projections.

Monitor for further deterioration and replace before 40% wear.

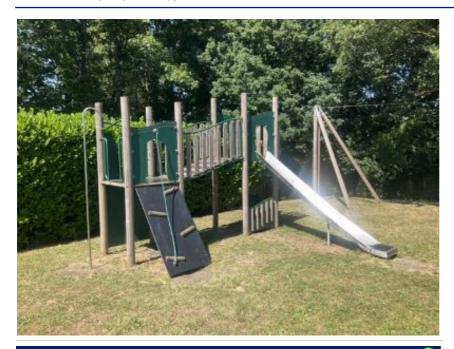
Multiplay - Junior

Timber is decayed.

Strimmer damage is present on posts, allowing water to enter and timbers to soften. Prevent further damage and check timbers for decay throughout the year.

Paintwork is in poor condition.

Around fireman's pole and lookout brackets. Monitor for cracks. Corroding around joint of fireman's pole.

Bolt(s) loose.

Cap missing.

Check on a routine basis., Replace affected parts.

Replace highlighted supports.

De-scale back to good base material and coat with lead free paint, using appropriate precautions. Repairs may be necessary where corrosion is severe., Read the notes for further action.

Replace.

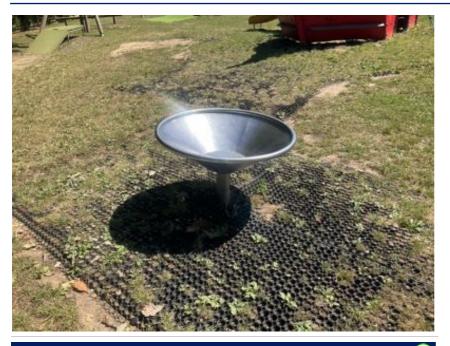
Rotator - Dish

Surface needs repair.

Additional cable ties recommended.

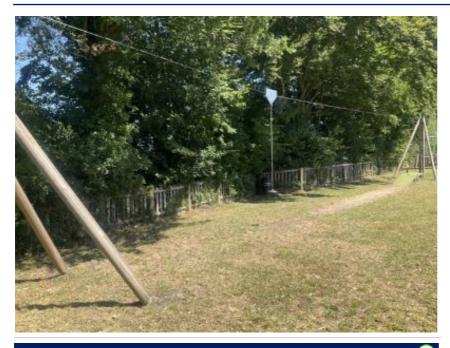
Cableway

Cables have been known to fail under load due to wear and corrosion. This is generally where the cable enters into a tube, top bar, sleeve or similar, where the wire is in contact and wears and frays over time, but can happen anywhere on the cable. It is important to inspect any hidden parts at least annually. Damaged cables require replacement. This cannot be determined during an annual inspection, and is excluded from our inspection. This can lead to a high risk if no action is taken. Refer to the manufacturer's instructions to ensure the correct check is carried out.

Item is damaged.

Carpet on ramp. Repair.

Seat damaged. Replace when the metal frame is exposed.

Some chain wear.

Monitor for further deterioration and replace before 40% wear.
